**NAVAL SUPPORT  
ACTIVITY  
NAPLES, ITALY  
(GAETA)  
FLEET MOORING  
UNDERWATER  
INSPECTION  
REPORT**

**NOVEMBER 1983**

OCEAN ENGINEERING  
AND CONSTRUCTION PROJECT OFFICE  
CHESAPEAKE DIVISION  
NAVAL FACILITIES ENGINEERING COMMAND  
WASHINGTON, D.C. 20374

FPO-1-83 (46)

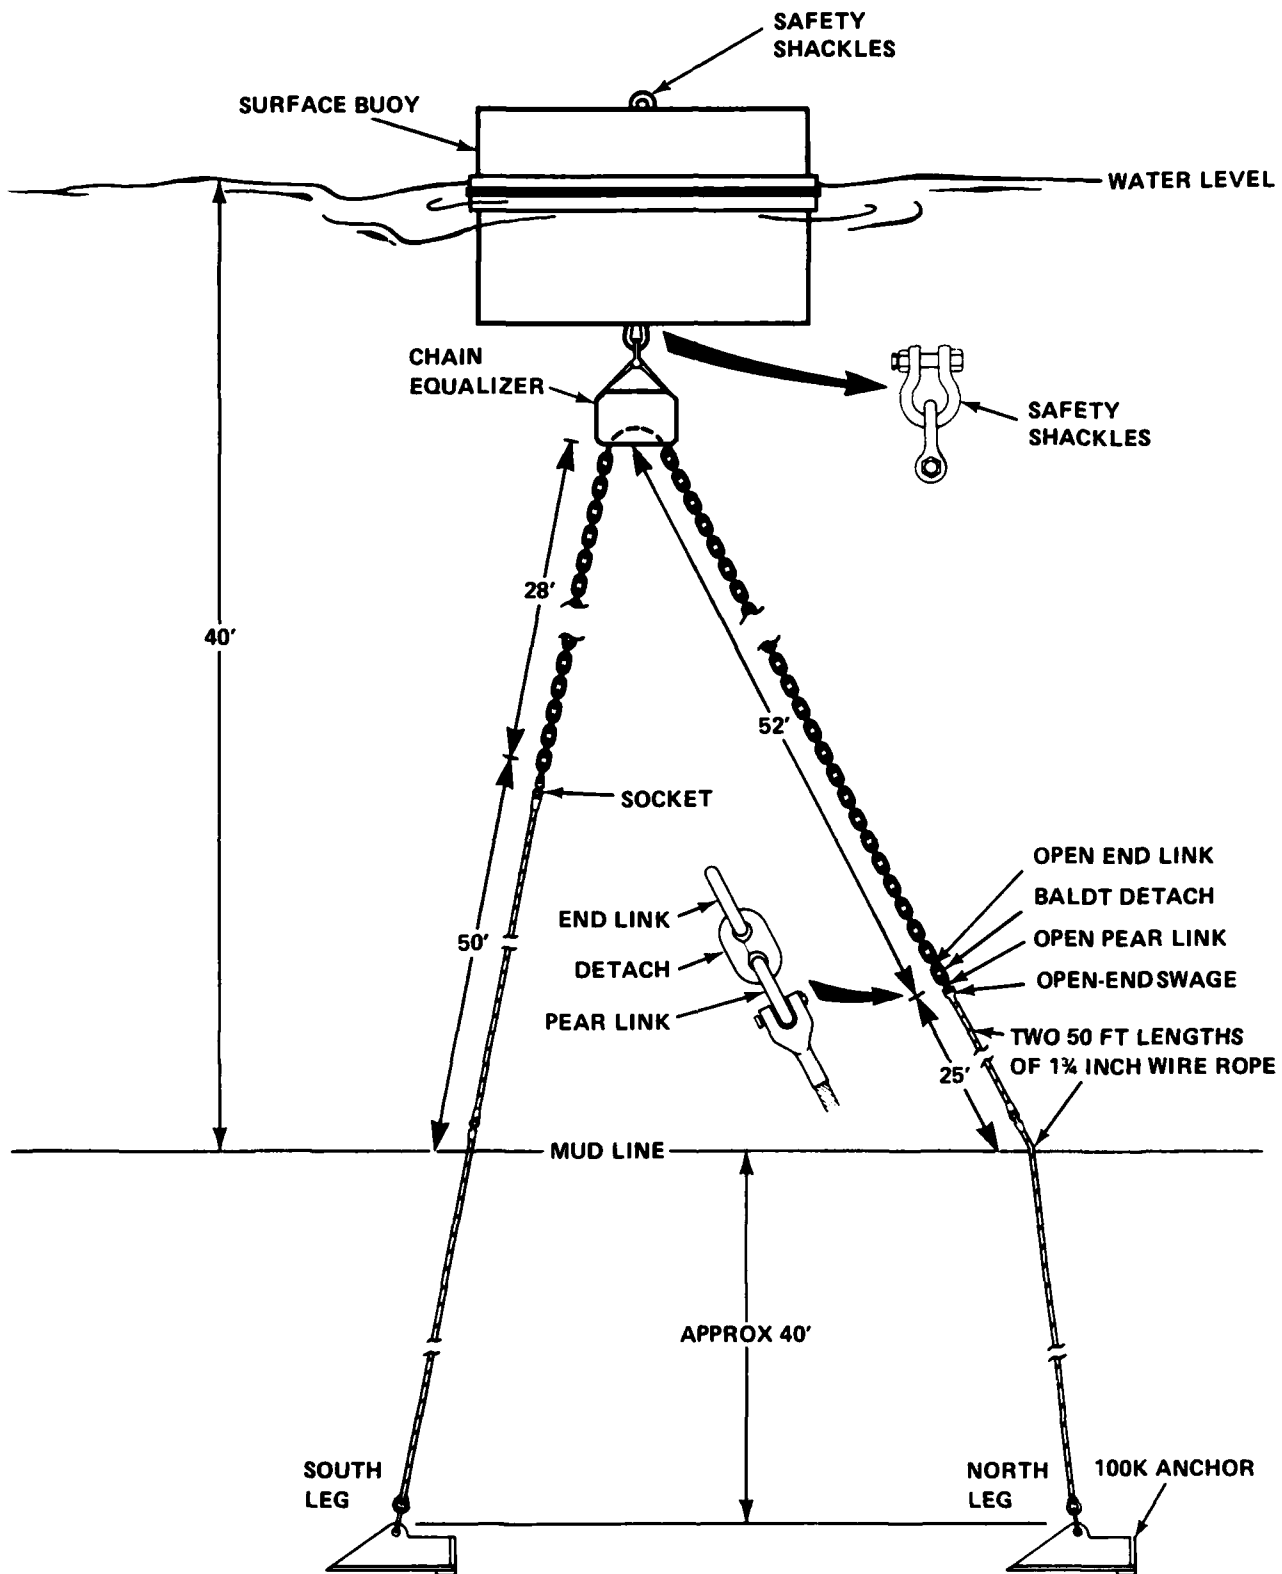
FIGURE A-1. GAETA BOW MOORING

The chain was originally 1 3/4-inch diameter and all measurements taken were greater than 90 percent of the original wire diameter. Between the surface and a water depth of 25 feet, the chain is covered with a heavy coating of marine growth. The chain is not centered in the equalizer, so that the southern leg is 28 feet long and the northern leg is 52 feet long (see Figure A-1).

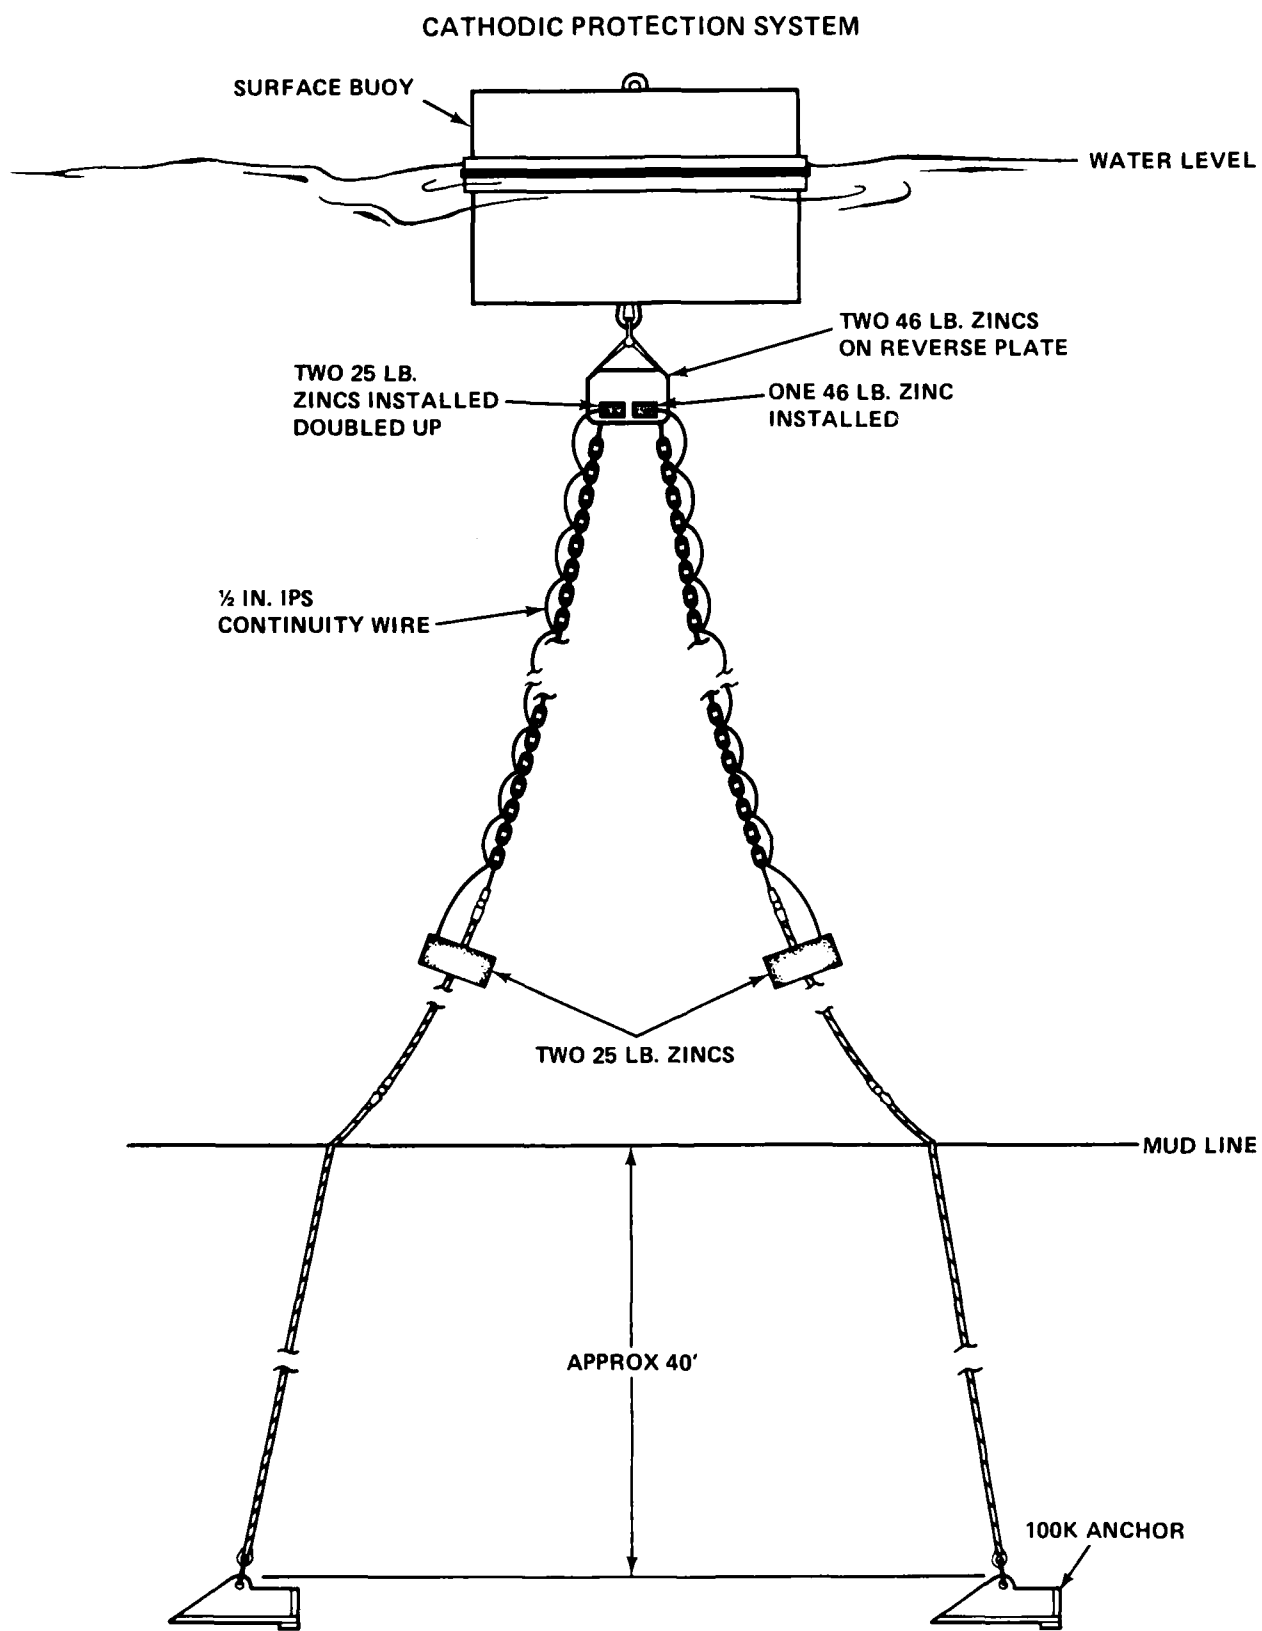
FIGURE B-1. GAETA BOW MOORING

The equalizer is in good condition, but as evidenced by heavy marine growth, the chain passing through it has probably not moved for several years. The four sacrificial zinc anodes that were attached to the equalizer when the mooring was installed in November, 1978, were found to be fully expended. The cause of this relatively rapid decay of the anodes is unknown.

Three 46-pound and four 25-pound sacrificial zinc anodes were available for installation. Two of the 46-pound zincs were attached with nuts and bolts to the outside of one equalizer plate while two of the 25-pound anodes were doubled up and attached to the outside of the second equalizer plate along with the third 46-pound anode.

One-half-inch continuity wire was then woven through the chain. The wire was attached with tie wraps in various locations where the chain had been cleaned to bare metal.

A 25-pound anode was mounted on each of the northern and southern anchor pendants, below the swage fitting which connects the anchor pendant to the equalizer chain. The 1/2-inch continuity wire was continued down from the chain and attached to each zinc anode. A schematic drawing of the cathodic protection system is depicted in Figure B-1.

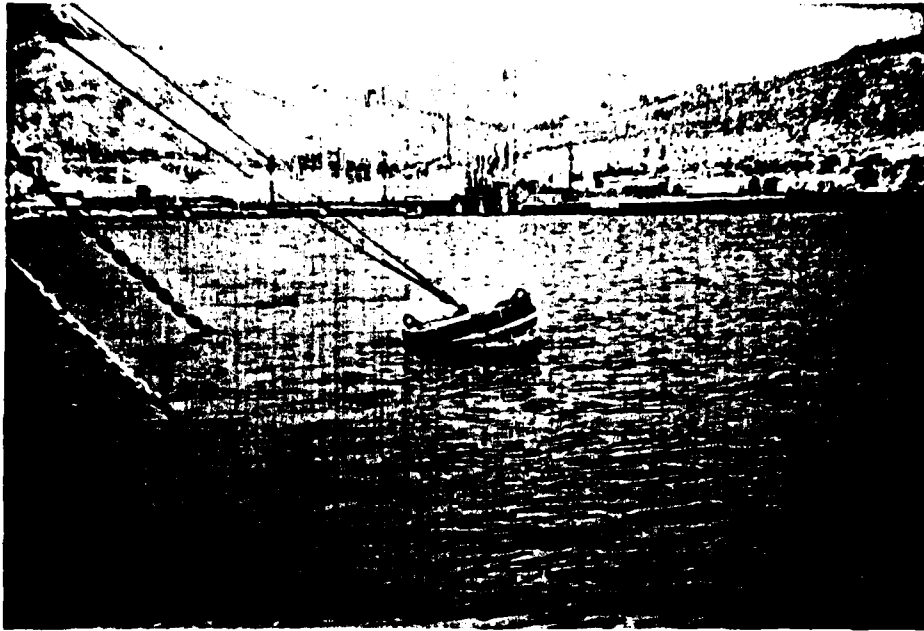
- o The buoy should be removed from the water and overhauled at the earliest practical time. In general, however, the mooring is in satisfactory condition for continued use.
- o The position of the bow buoy system should be reviewed as part of the transition planning for the new Flagship. Preliminary indications are that the buoy will be better positioned for USS CORONADO than for USS PUGET SOUND, but the issue deserves further attention.

BOW MOORING. NOTE THE STEEP HAWSER ANGLE

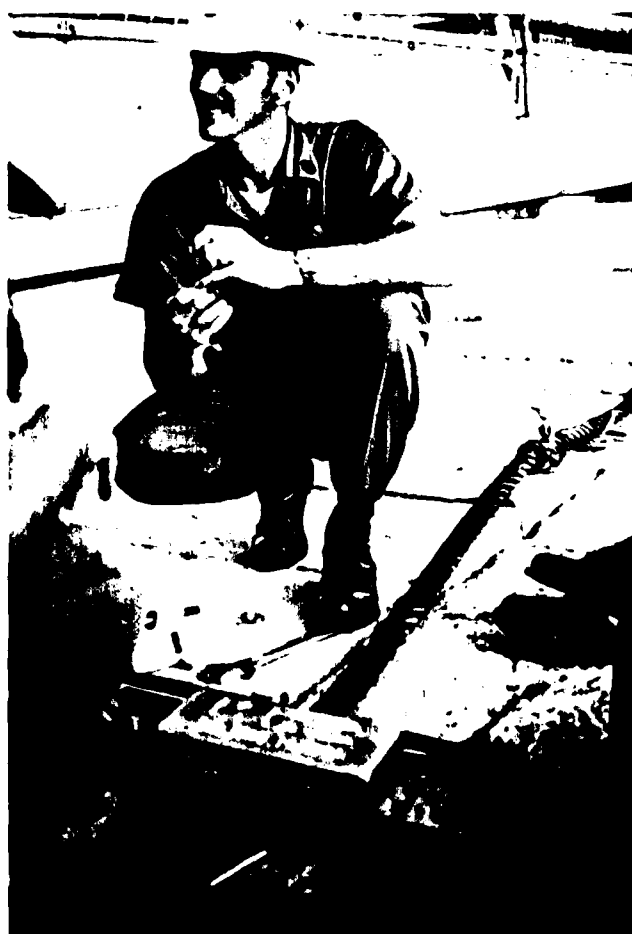
Each of the anchor pendants attached to each end of the chain passing through the equalizer consists of two 50-foot sections of 1 3/4-inch steel wire rope. The bitter end of each anchor pendant is connected to a 100 KIP PEA. About 5 feet of the southern anchor pendant, just below the swage fitting which attaches the pendant to the equalizer chain, was found to be damaged and necked down to approximately 1 1/4 inches, or about 71 percent of original wire diameter. Of these two 100-foot lengths of wire rope less than half of each was visible for inspection.

**BOW MOORING. NEW SOUTHERN LEG 1 3/4"  
WIRE ROPE ANCHOR PENDANT WITH A 25-  
POUND ZINC ANODE ATTACHED.**

UCT One divers replaced the upper 50-foot section of the southern leg's anchor pendant. After removal of the damaged section, it was packed for shipment to the Naval Civil Engineering Laboratory (Attn: Mr. James Miller L42) for failure analysis. Shipment of the new anchor pendant from the United States to Gaeta took one week.
